Home Energy Audit

123 Main St

Berthoud, CO 80513

Inspection Date: 7/7/2007

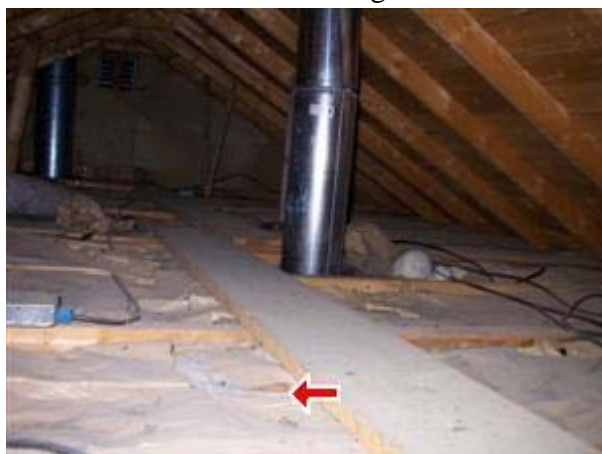
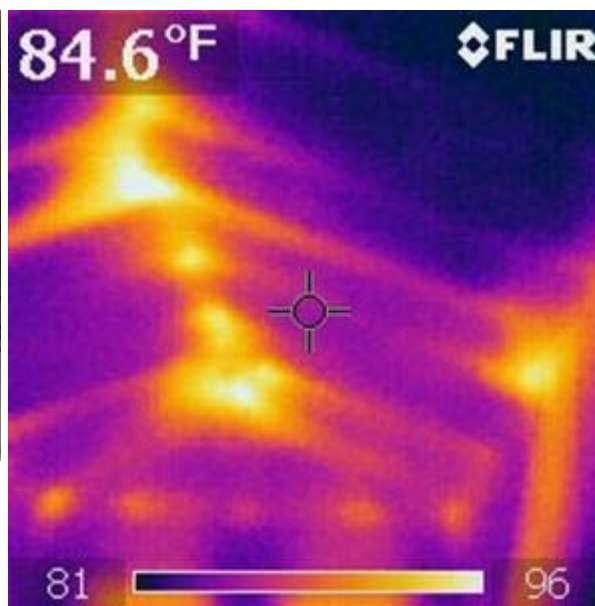
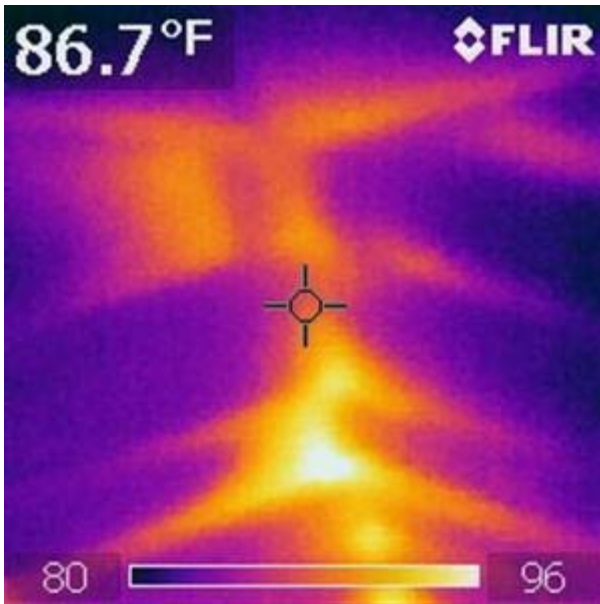
- 🏠 (1) The attic is insulated with about 4" of fiberglass batt insulation. I recommend adding another 6-8" of blown insulation in the accessible attic area. Recommended insulation levels in our area in the attic is R-50. IR scans of the ceiling and attic areas show many areas where the insulation is inadequate, causing a considerable amount of heat gain and heat loss in these rooms.

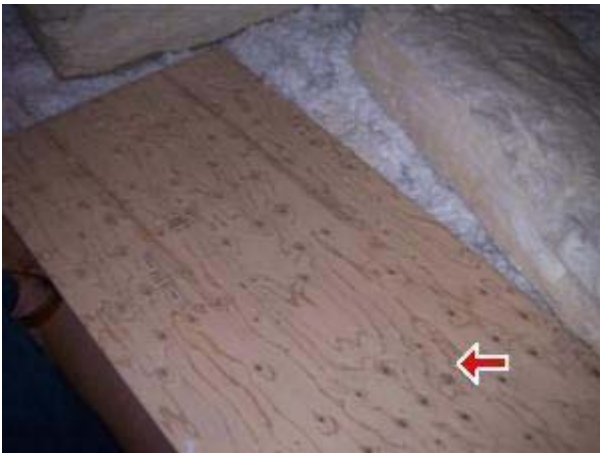
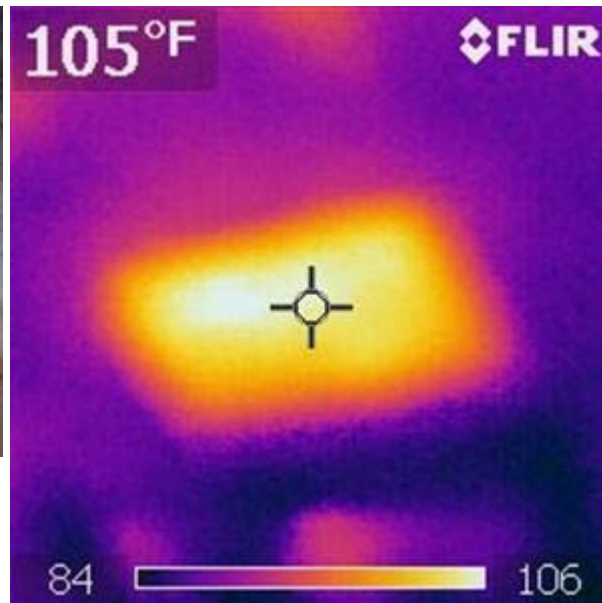
- 🏠 (2) Weatherstrip the attic hatch and attach insulation to the upper part to approximately R-30. If possible, have tightening cam latches installed to keep hatch securely closed.

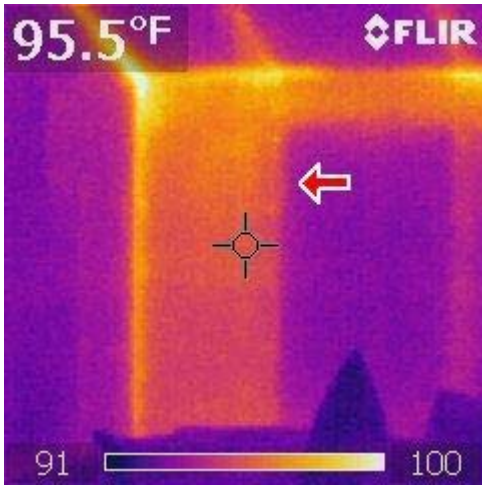
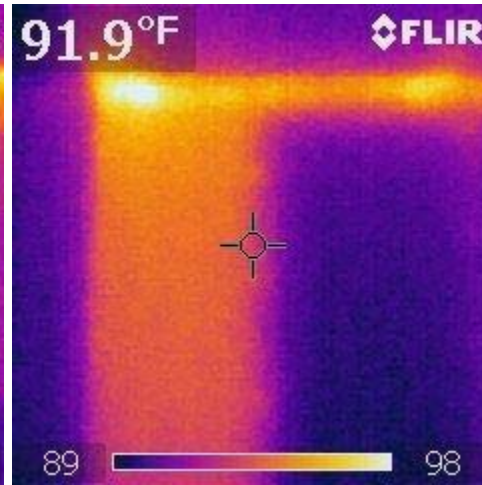
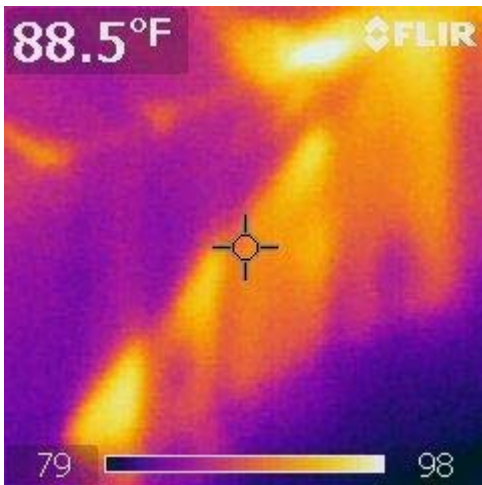
- 🏠 A basic inspection of the wall insulation in a few areas was done, by Infra-Red (IR) Scanning. This limited inspection showed that the walls have areas where insulation is missing. This can be a considerable expense, and would require drilling access holes in either the outside wall siding or inside drywall. I recommend you consult with an insulation company and understand the process and costs associated.

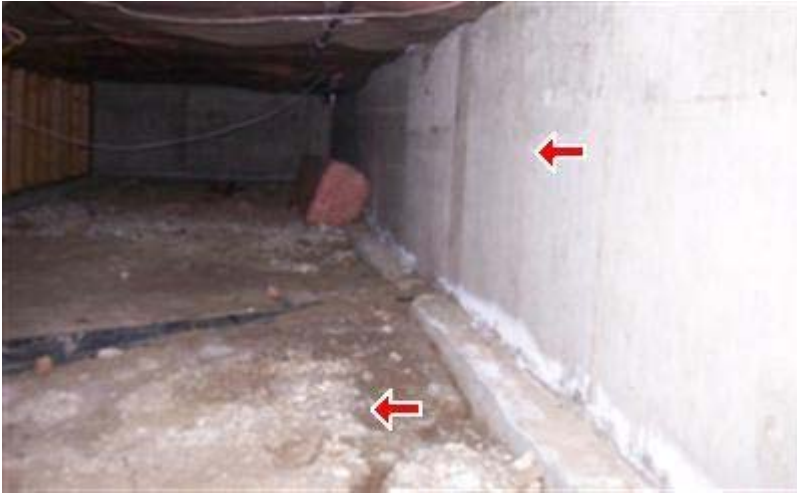
1.2 Picture 1

The rim joist area and the foundation walls in the crawlspace are not insulated well. The rim joist is the area above the foundation wall but below the floor area, which is exposed along the outside edges of the home. Add cut pieces of fiberglass insulation to this and any exposed areas of the rim joist accessible. For the foundation walls, drape insulation down to the crawlspace dirt floor, attaching it to the top of the sill plate. For the floor of the crawlspace, lay down a plastic sheeting vapor barrier and attached this to the foundation wall edge. Lay the draped insulation on the walls over this sheeting. If outside vents for the crawlspace exist, close these vents and seal them off with insulation batts or foam board insulation, and foam spray the edges if possible.

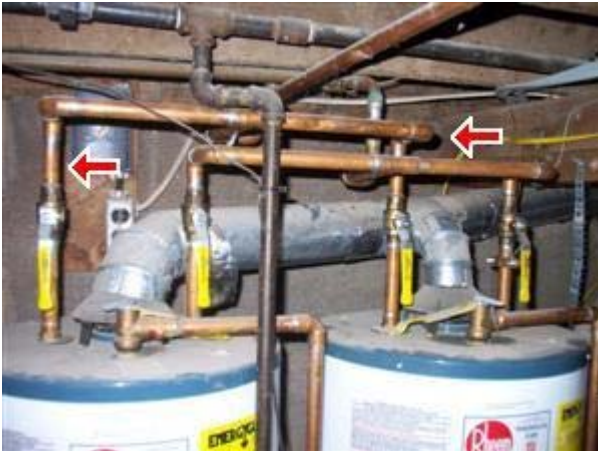
1.3 Picture 1

- 🏠 Insulate accessible hot water piping coming from the water heater with low cost foam wrap insulating material.

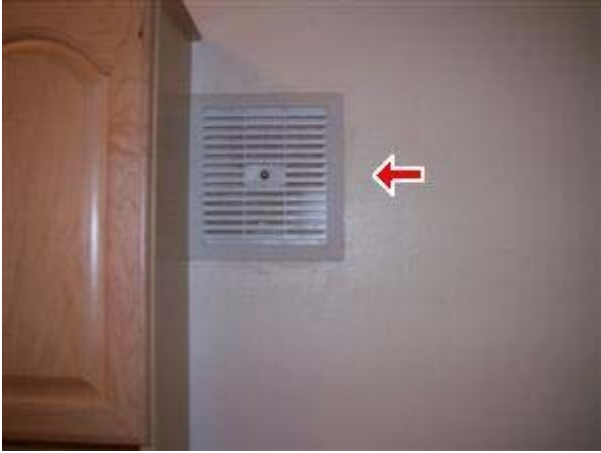
1.5 Picture 1

- 🏠 Both vent fans are not connected to the outside, and do not have any damper installed to prevent outside air from entering or from heat escaping. The vent fans need a proper roof-mounted vent with a built in damper installed, to prevent heat loss and air entry.

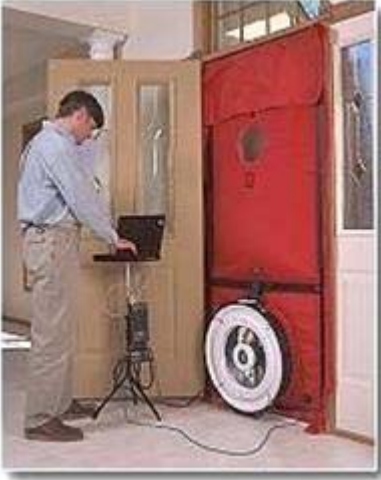
2.0 Picture 1

- The air sealing in the home needs to be improved. The blower door test measured 4900 CFM at 50 PA, which calculates to 0.92 NACH (Natural Air Changes per Hour). A NACH over 0.35 indicates leakage rates where air sealing efforts would be beneficial. Air sealing specific areas are noted in the appropriate section of the report.

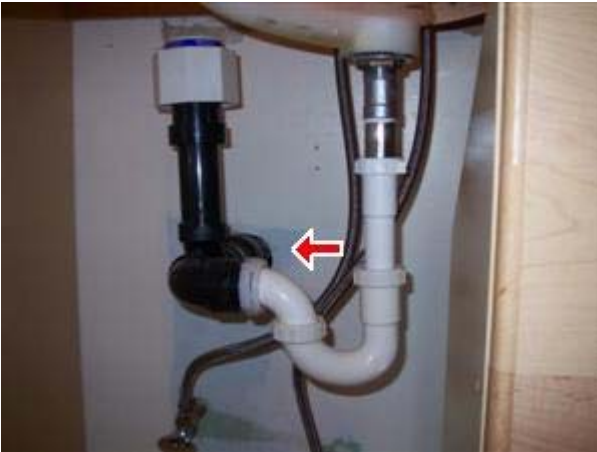
2.3 Picture 1

- (1) Seal with blow foam the plumbing pipe entries below the kitchen sink, to prevent air leakage in these areas.

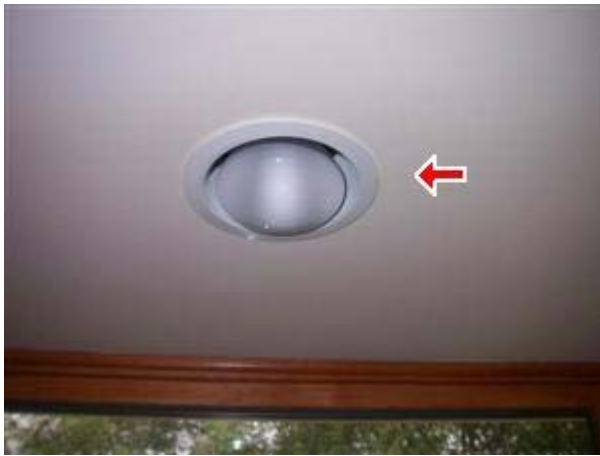
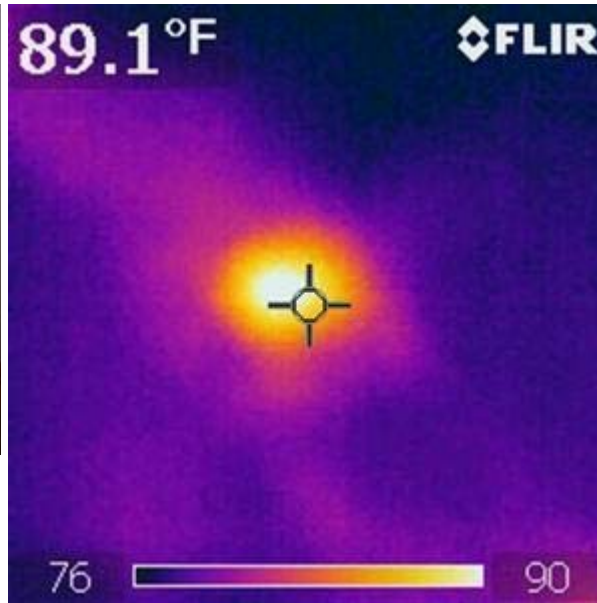
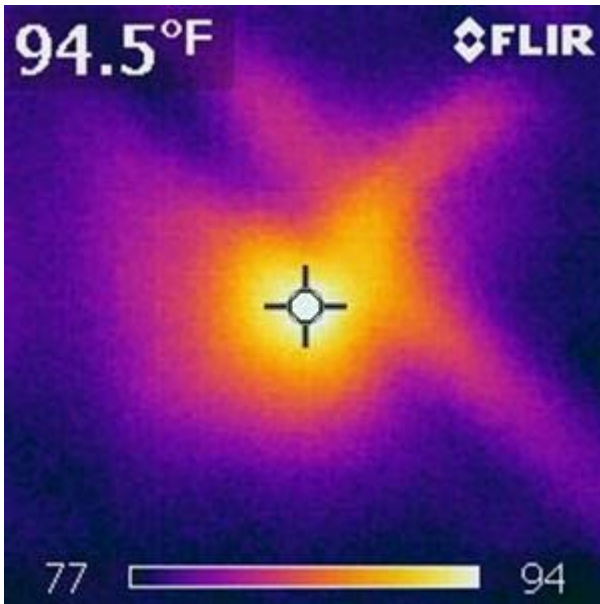
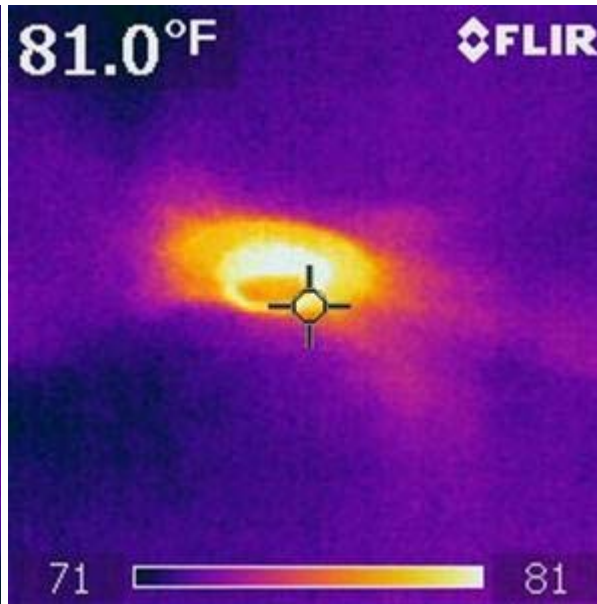
- (2) Seal the recessed light fixtures in the home. Seal around the edges and any holes present when the trim

and bulb are removed, with an appropriate fire rated caulking. For any upstairs recessed light, that are accessible in the attic, build a box out of drywall that will cover the light fixture, allowing for a 3" clearance on all sides of the fixture. Place this box over the can light, and caulk or seal the edges. Then you can move insulation all around this box.

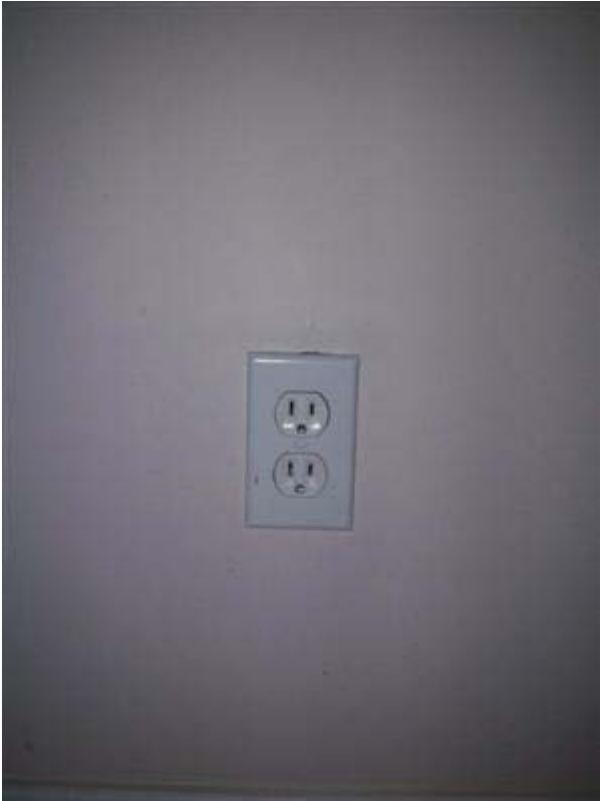
2.3 Picture 6

- 🏠 (3) Install foam sealing gaskets behind exterior wall electric outlet and switch covers. Plug unused electrical outlets on exterior walls with child-safety plugs. These items can be purchased at any hardware store. It is recommended power be removed to the outlets and switches when installing gaskets, for safety.

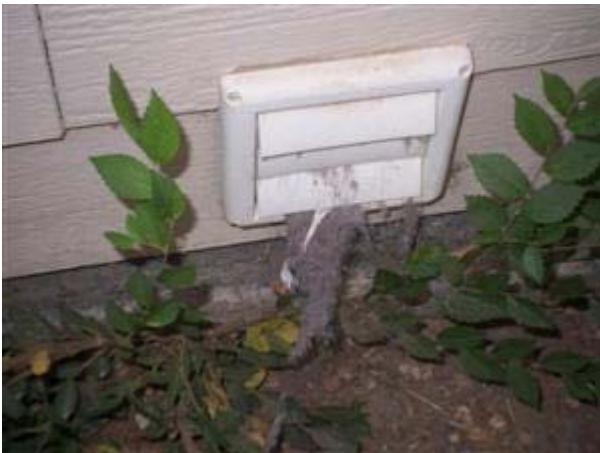
2.4 Picture 1

(1) Clean out the build up of lint in the outside clothes dryer exhaust. This will prevent air penetration into the dryer area.

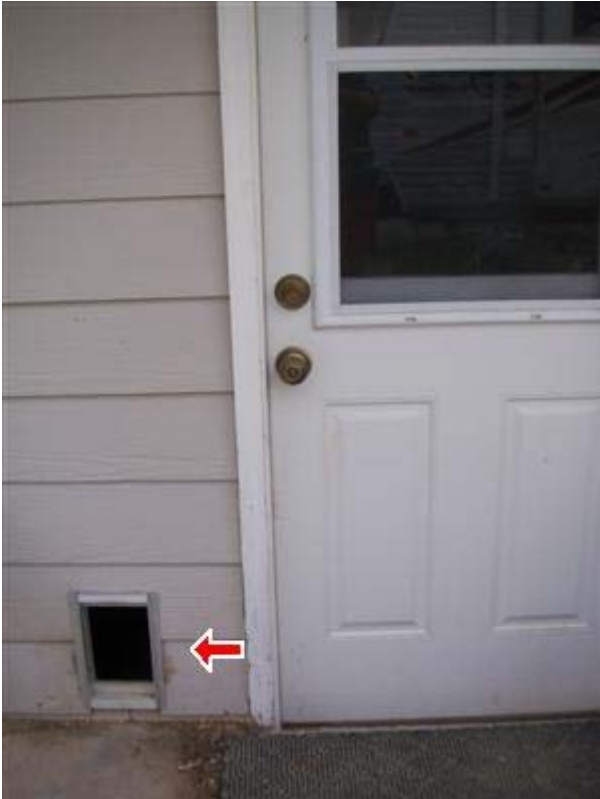
2.4 Picture 2

(2) The cat door is significantly contributing to the air leakage present in the home. I would recommend you investigate a better insulated and weatherstripped door flap for the cat door. Visit the following for one possible option:

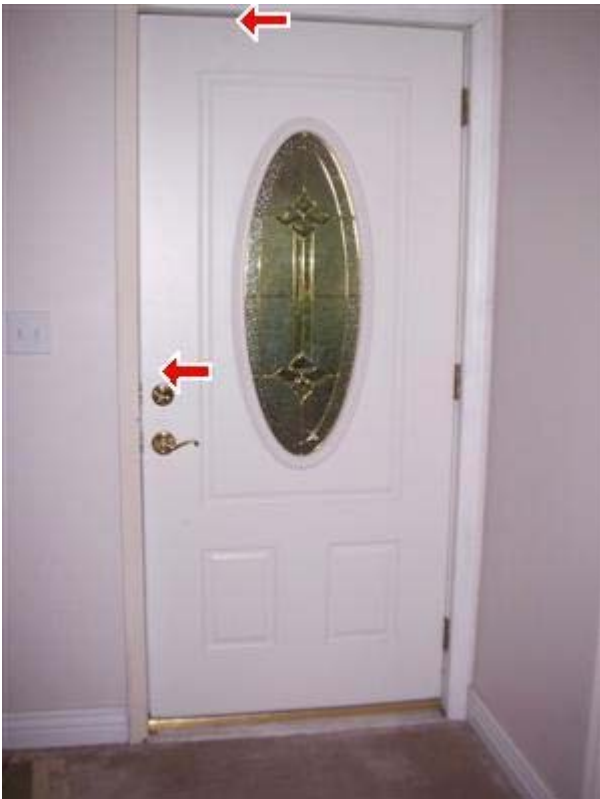
2.5 Picture 1

- 🏠 Update the weatherstripping on the front door and patio sliding door to prevent air leakage and heat loss.

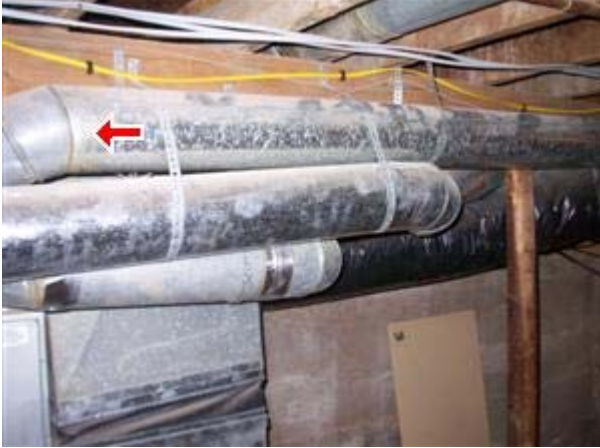
2.6 Picture 1

**Duct Leakage:** during the blower door test, there was a significant amount of air infiltration coming through the return registers in the upper level of the home. This indicates that outside air is penetrating the return duct system and that the ducts need to be sealed. When outside air is penetrating the return system, the efficiency of the furnace is reduced, and the furnace needs to work harder than necessary. The leakage is most likely in the attic or in the wall cavity where the returns are run. An HVAC contractor will need to investigate further and determine where the leakage is occurring, and seal these areas.

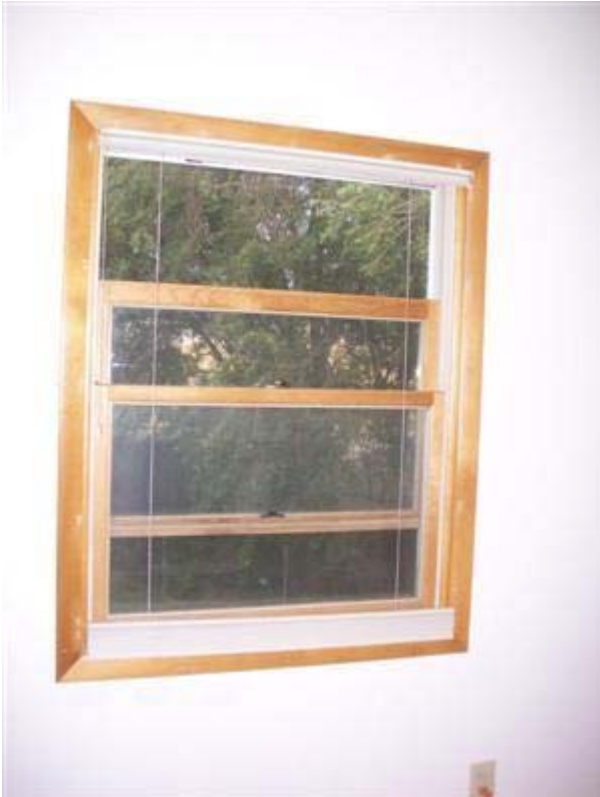
3.0 Picture 1

Most of the windows on your home have air leakage around the edges of them. I would recommend you consider repairing the weatherstripping on the windows. The following article has a section on windows, and discusses repair versus replacement;

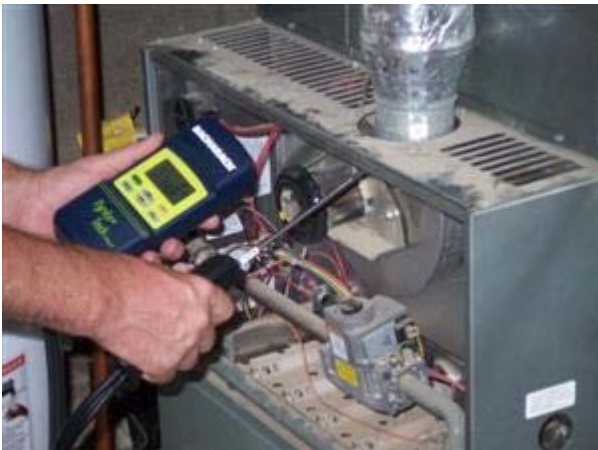
4.0 Picture 1

- 🏠 The furnace operational performance was tested with a Combustion Safety Analyzer, to determine how efficiently the unit is running. While your furnace is an +80% efficient unit, the actual performance was measured at 65%. This indicates that your furnace needs to be serviced and adjusted. I recommend an HVAC contractor come in before the next heating season, to performance a tune-up, cleaning and adjustment of your furnace system.

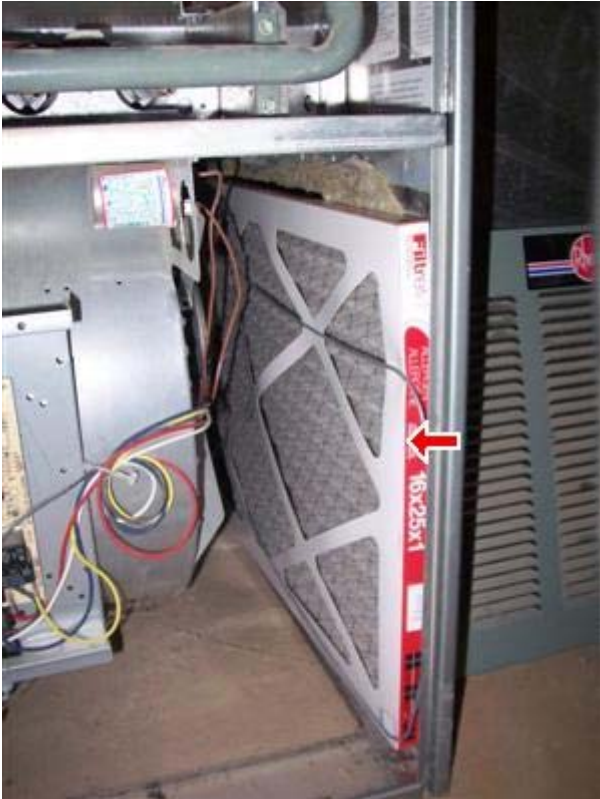
4.4 Picture 1

- 🏠 The disposable filter is dirty. The filter needs to be replaced.

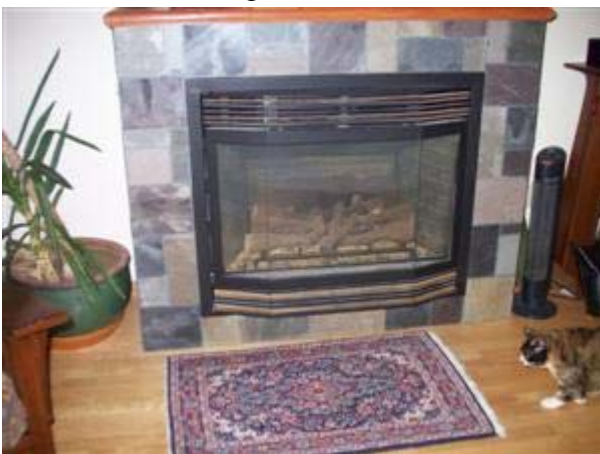
4.7 Picture 1

- 🏠 Air seal around the outside edges of the fireplace trim with appropriate caulking. There is a considerable amount of air leakage around this area.

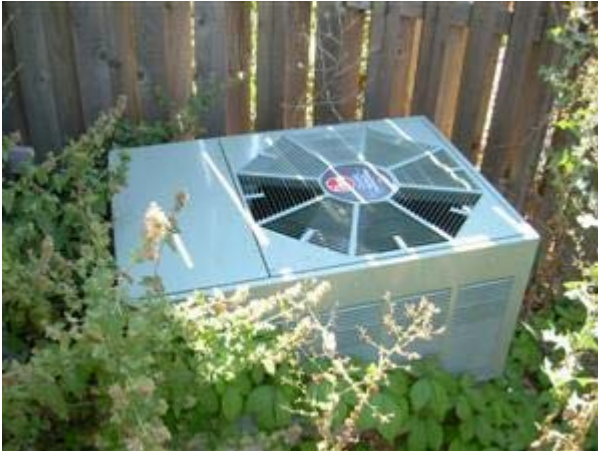
5.0 Picture 1

- 🏠 Ensure that any vegetation and/or leaves be cleaned from around the outside of the compressor, to allow for optimum performance. Also, the AC unit is older and the coolant level may be low and may need re-charged. I recommend an HVAC contractor perform a tune up of your AC system, to optimize performance and efficiency.

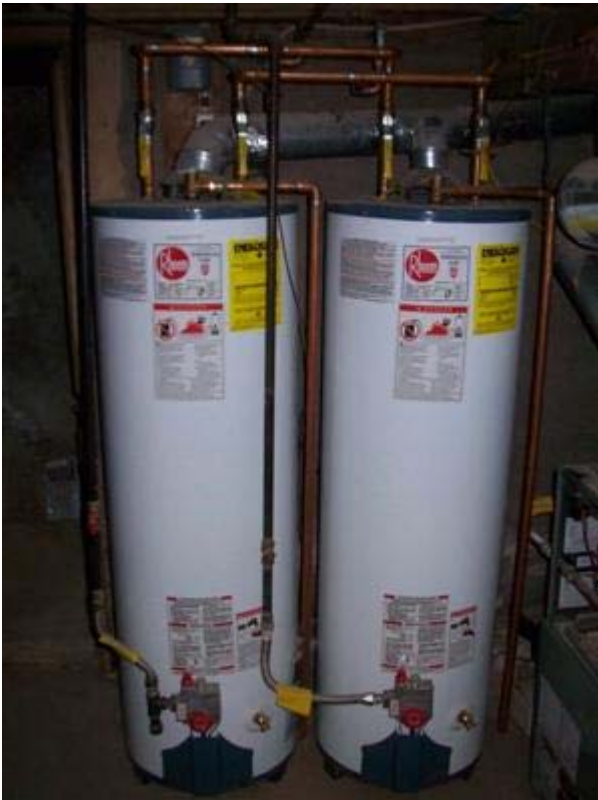
6.1 Picture 1

- 🏠 Consider installing an insulating blanket on the hot water heater, which will help reduce energy use and ambient losses.

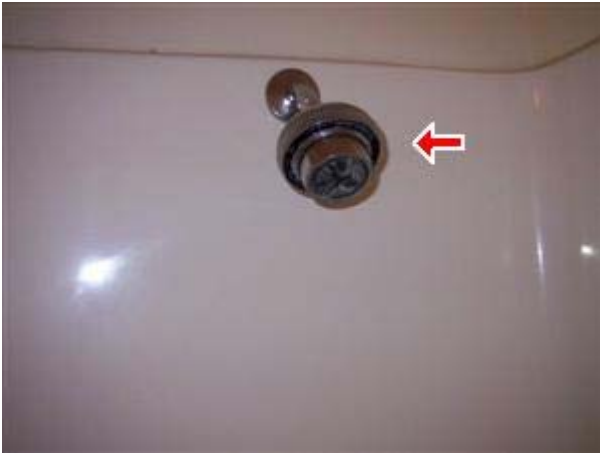
6.3 Picture 1

- 🏠 For water savings, consider changing your shower heads to low flow type.

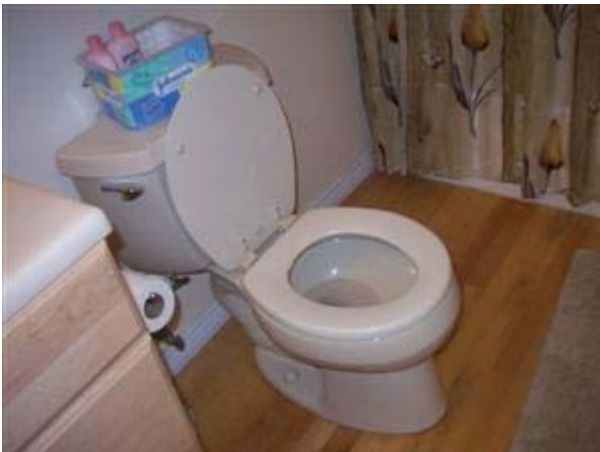
6.4 Picture 1

- 🏠 For water savings, consider replacing the hall bathroom toilet with a low flush, maximum 1.6 GPF rated.

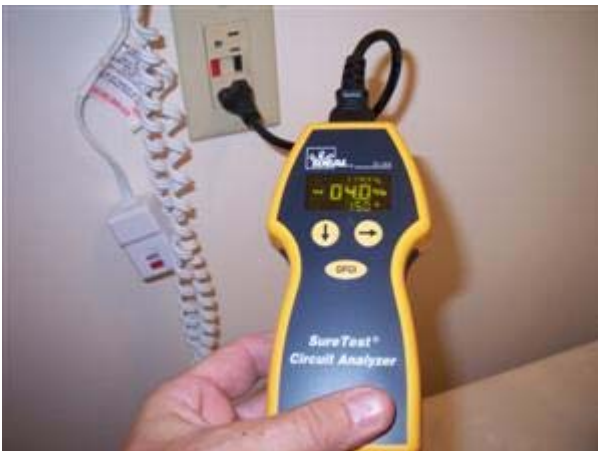
7.2 Picture 1

Several random electrical outlets in your home where tested for stress and safety, with measurements made with a specialty meter to determine if any hazardous wiring conditions exist. If this condition were to exist, it may be causing higher electrical use, as well as presenting a hazardous, un-safe condition. All of the outlets measured exhibited a voltage drop when loaded of less than the recommended 5% threshold. No actions are needed - this is noted for your information.

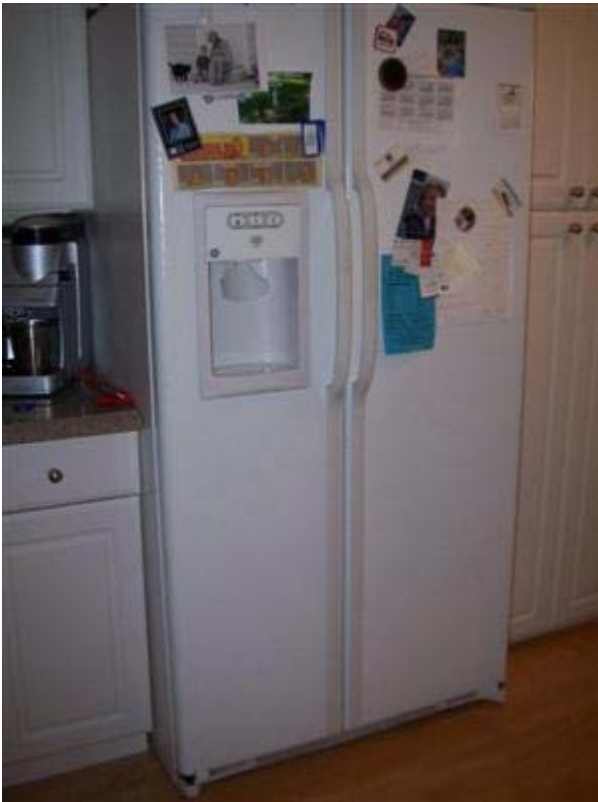
8.0 Picture 1

Your refrigerator power consumption was measured, and is consuming approximately 50 kWh per month, or approximately 600 kWh per year. This is about 2-3 times more energy than a newer Energy Star refrigerator. Consider replacement when possible. In the meantime, regularly clean the refrigerator condenser coils beneath or behind the unit to ensure optimum efficiency is gained from your current unit.
