Scott Home Inspection, LLC

Inspection Report

123 Main St

Anytown CO

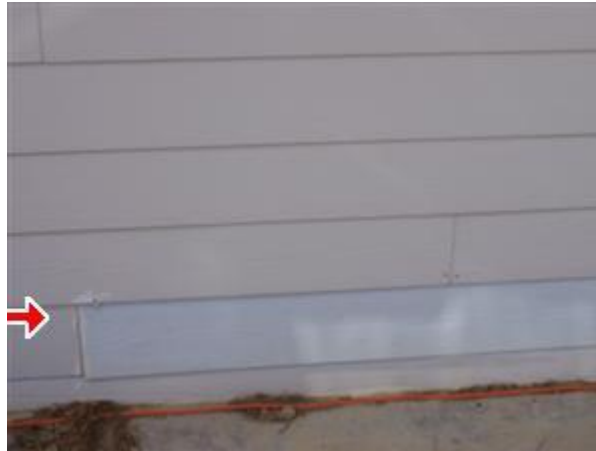
1.0 Picture 1

- ☒ The Cement board at the garage right side (facing front) is loose and damaged. Deterioration can eventually occur if not corrected. A qualified person should repair or replace as needed.

The Cement board at the garage right side (facing front) is loose and damaged. Deterioration can eventually occur if not corrected. A qualified person should repair or replace as needed.

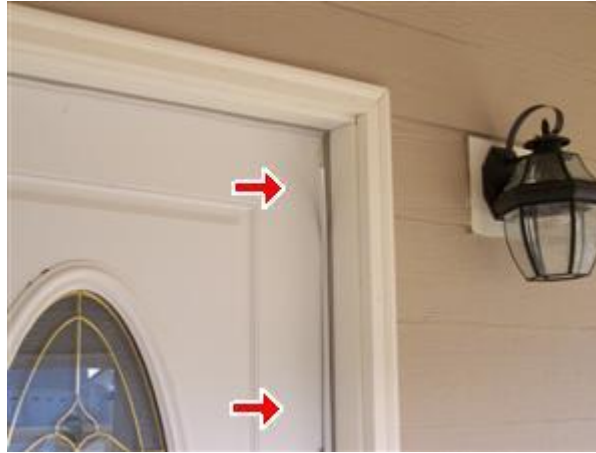
1.2 Picture 1

- ❏ The main entry door needs weather-stripping repaired or replaced. This can cause some heat loss in winter and loss of cool air in summer if not corrected. A qualified person should repair or replace as needed.

The main entry door needs weather-stripping repaired or replaced. This can cause some heat loss in winter and loss of cool air in summer if not corrected. A qualified person should repair or replace as needed.

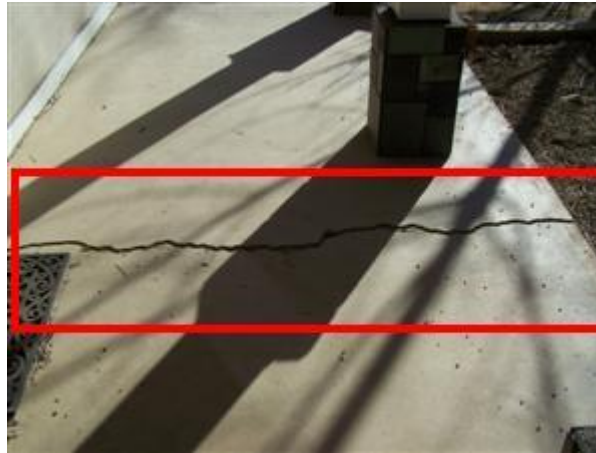
1.4 Picture 1

- ❏ The Concrete patio at the front of home has settlement cracks and is uneven, and can be a tripping hazard. A fall or injury can occur if not corrected and further deterioration can occur if not repaired. A qualified contractor should inspect and repair as needed.

The Concrete patio at the front of home has settlement cracks and is uneven, and can be a tripping hazard. A fall or injury can occur if not corrected and further deterioration can occur if not repaired. A qualified contractor should inspect and repair as needed.

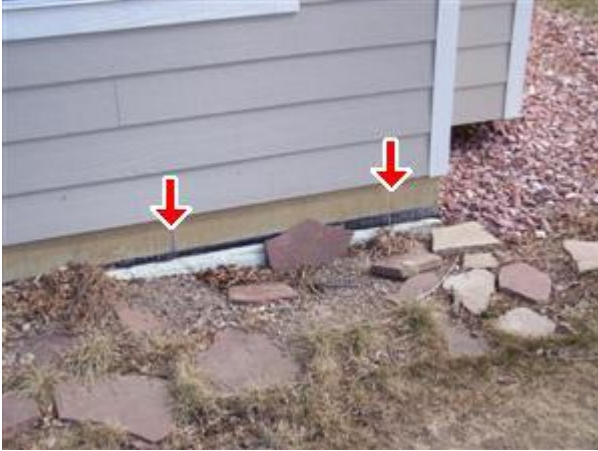
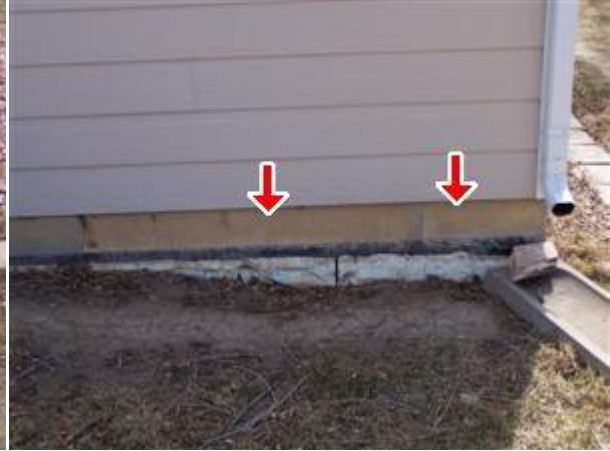
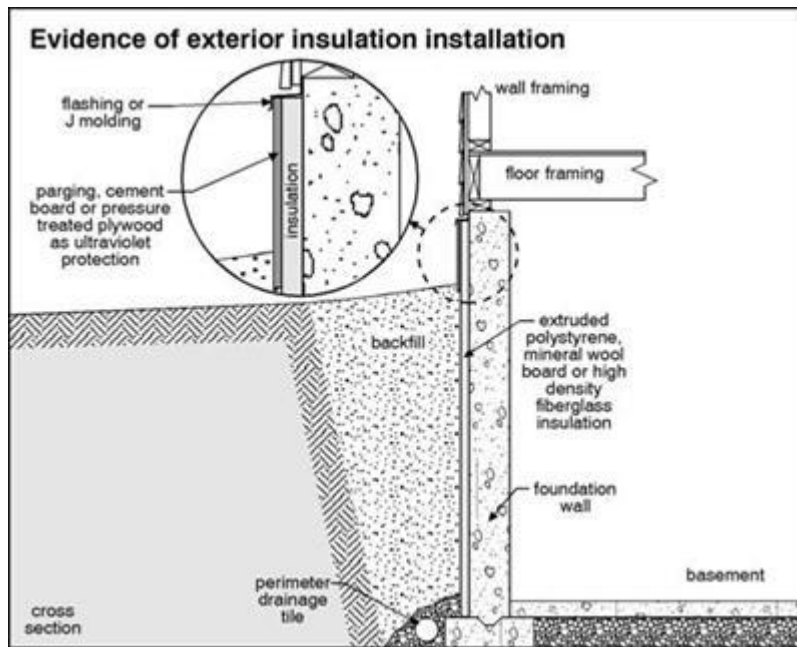
■ The Foundation wall at the left side (facing front) and right corner (facing rear) has exposed exterior insulation. The insulation should not be exposed, to prevent damage & deterioration. The foundation grading in this area should be improved.

The Foundation wall at the left side (facing front) and right corner (facing rear) has exposed exterior insulation. The insulation should not be exposed, to prevent damage & deterioration. The foundation grading in this area should be improved.

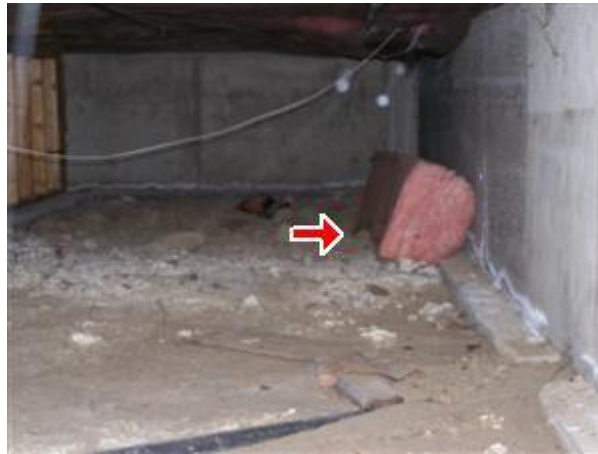
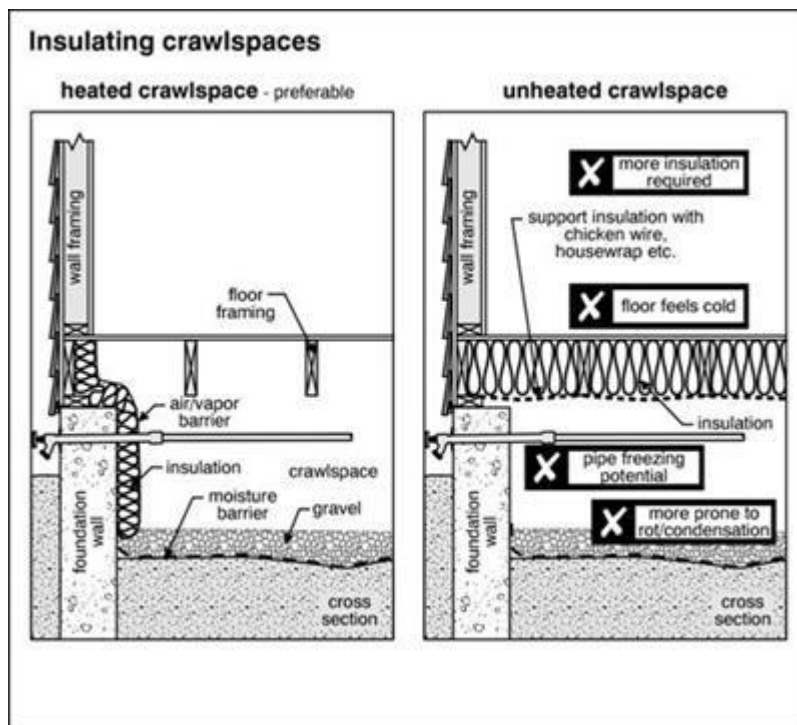
The insulation is loose/fallen in the crawlspace under the living room. Heat loss can occur more on this home than one that is properly insulated. A qualified person should repair or replace as needed.

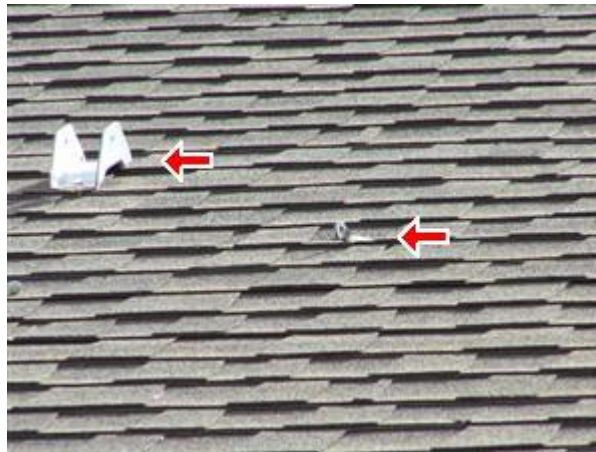
3.0 Picture 1

- (1) There are old, un-used brackets mounted on the roof, that appear to be from an old antenna or dish. While the brackets seem well secured, there is a concern for developing roof leaks at the point of penetration. Recommend removal of these brackets, and properly sealing penetration holes, to prevent any future roof leaking at this point.

(1) There are old, un-used brackets mounted on the roof, that appear to be from an old antenna or dish. While the brackets seem well secured, there is a concern for developing roof leaks at the point of penetration. Recommend removal of these brackets, and properly sealing penetration holes, to prevent any future roof leaking at this point.

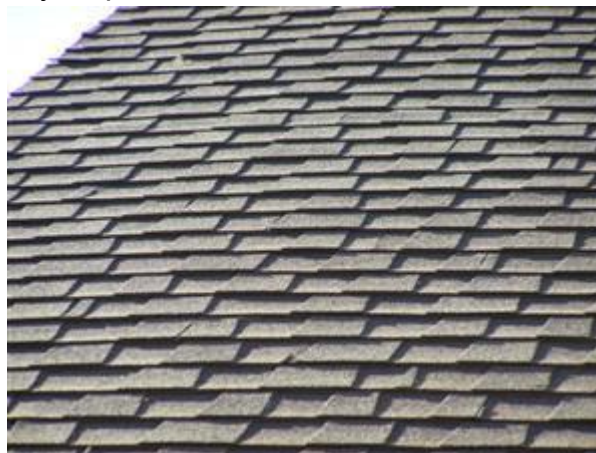
3.0 Picture 2

- (2) The roof was walked and fully inspected. No concerns or defects were noted at this time.

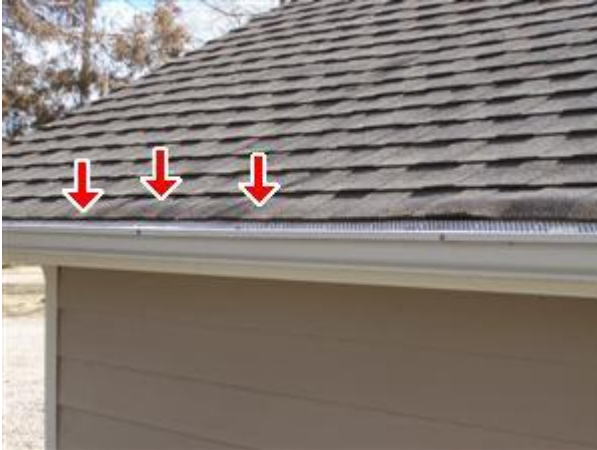
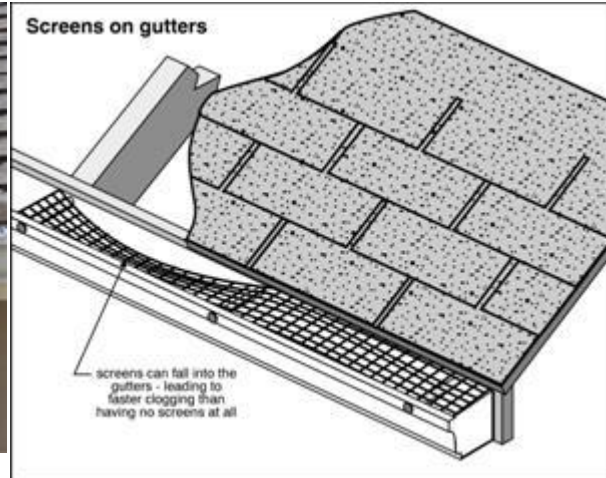
- The gutter screens are loose at the left corner (facing rear) rear of home. If gutter screens are not properly in place, leaves can contribute to a clog which can cause deterioration of fascia, soffit or roof edge. It can also cause gutters to pull loose and lead to possible water intrusion. Recommend repair as desired.

The gutter screens are loose at the left corner (facing rear) rear of home. If gutter screens are not properly in place, leaves can contribute to a clog which can cause deterioration of fascia, soffit or roof edge. It can also cause gutters to pull loose and lead to possible water intrusion. Recommend repair as desired.

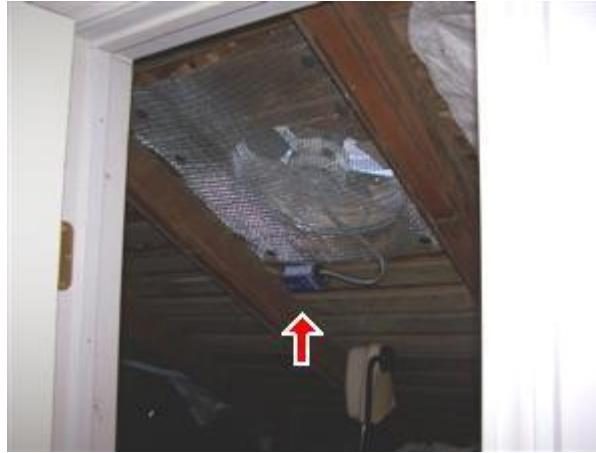
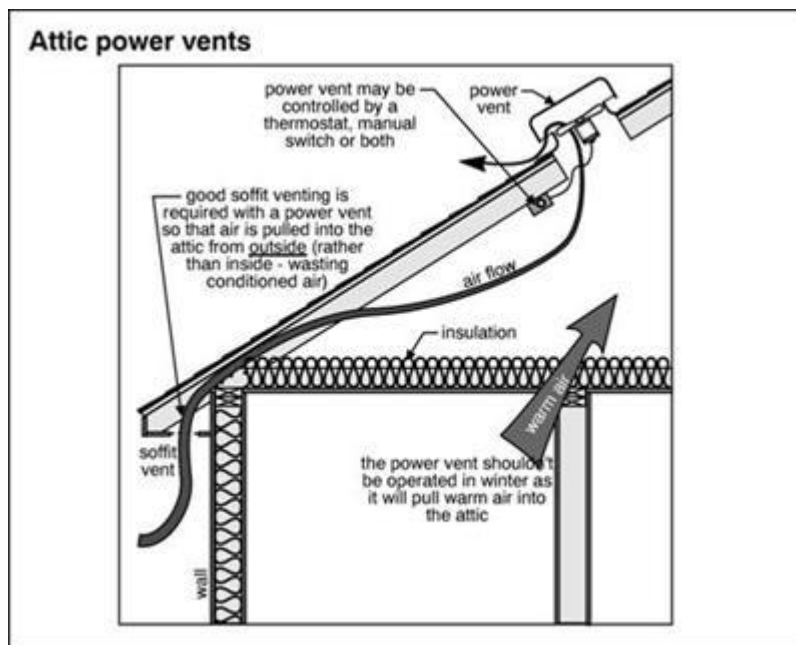
The thermostatically controlled vent fan in the attic is functioning. Location of thermostat control is noted on report detail photograph, for reference. This is for your information. Adjustments are possible, and the homeowner should become familiar with the method of setting.

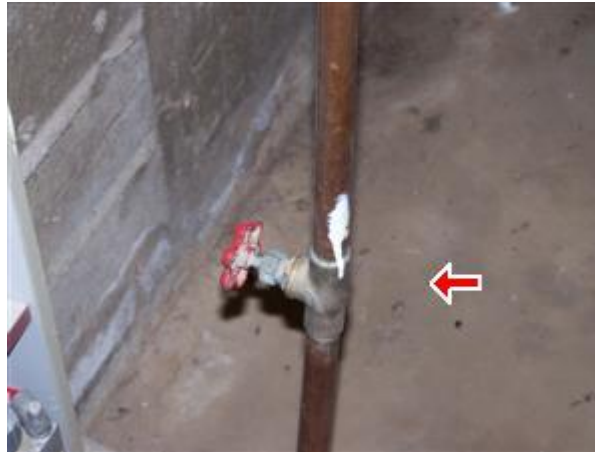
4.0 Picture 1

The main shut off is the red knob located in the basement on the rear wall. This is for your information.

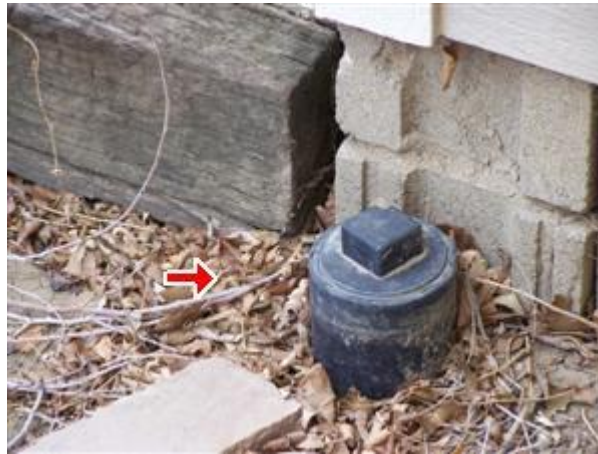
4.4 Picture 1

There is a plumbing clean-out located outside, which allows access to the waste drain, in the event of back-up or clogs. This item is noted for reference only, and for future maintenance consideration.

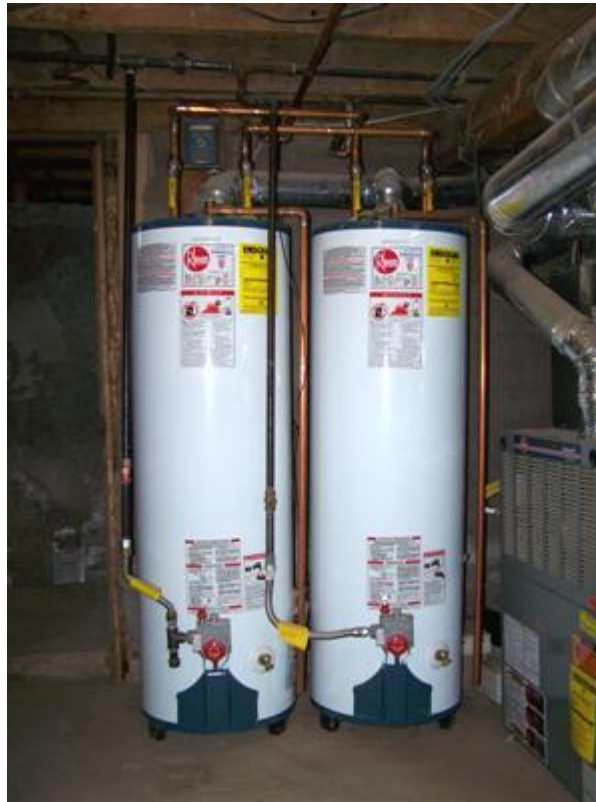
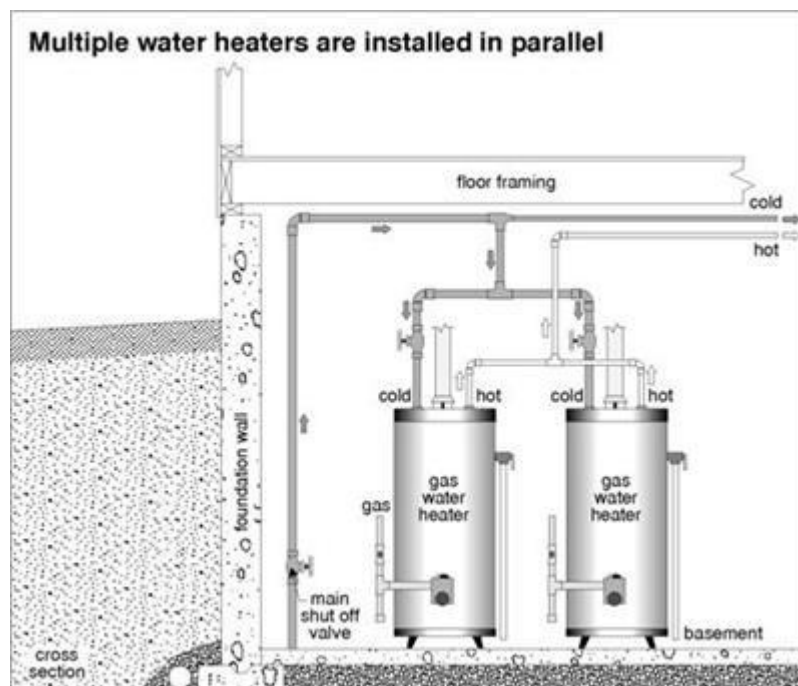
The dual hot water heater installation is set-up properly in a parallel configuration.

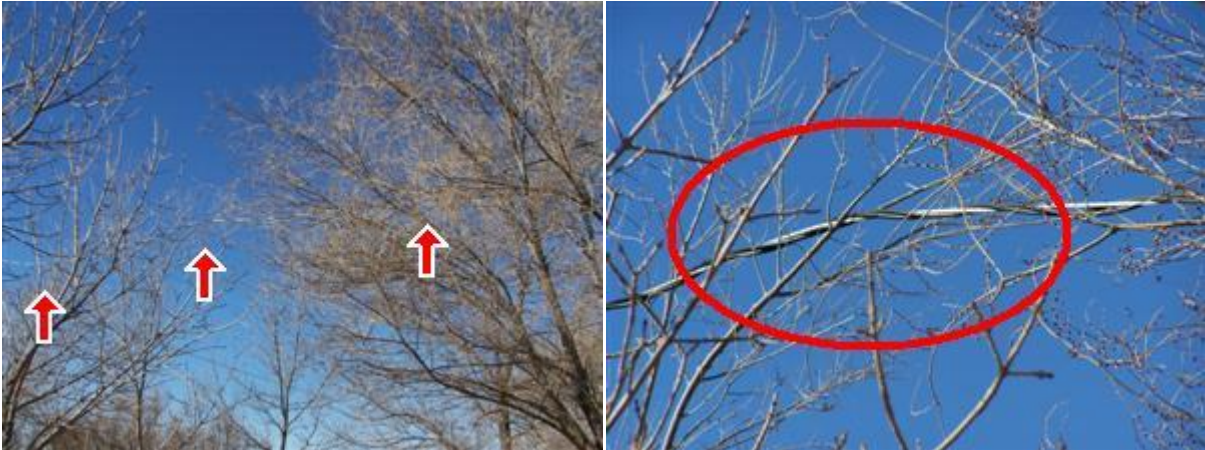
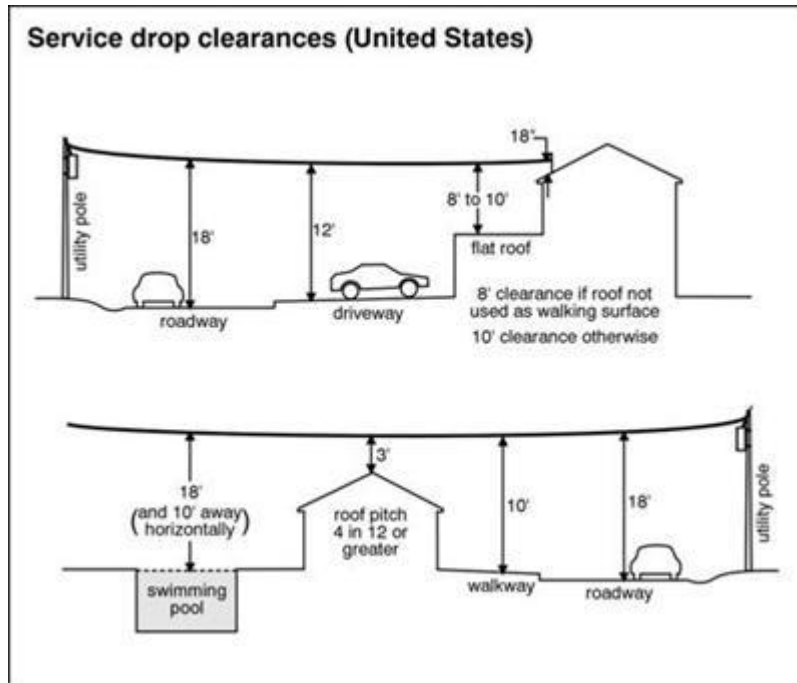
⚡ The electrical service conductors are in contact with trees, between the main service drop at the road, and the service entrance connection at the house. This can cause fraying of wires and possible damage to wires. It is recommended that trees and vegetation be trimmed around service entrance conductors, to prevent damage.

The electrical service conductors are in contact with trees, between the main service drop at the road, and the service entrance connection at the house. This can cause fraying of wires and possible damage to wires. It is recommended that trees and vegetation be trimmed around service entrance conductors, to prevent damage.

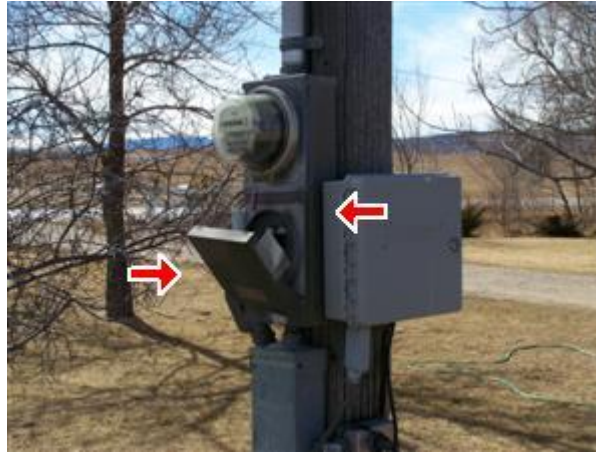
5.1 Picture 1

The main panel box is located at the outside service pole. The panel door is damaged. This is a safety issue that needs to be corrected and could result in water entry and future corrosion. A qualified licensed electrician should correct as needed.

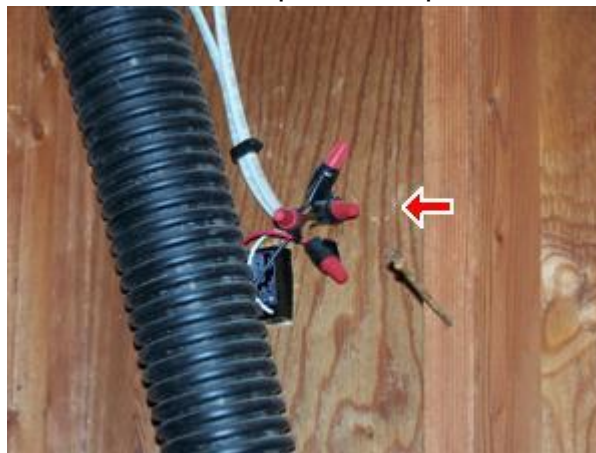
5.4 Picture 1

- ⚡ (1) There is exposed wiring at the light fixture in the garage. This is a safety issue that needs to be corrected. A qualified licensed electrician should perform repairs that involve wiring.

(1) There is exposed wiring at the light fixture in the garage. This is a safety issue that needs to be corrected. A qualified licensed electrician should perform repairs that involve wiring.

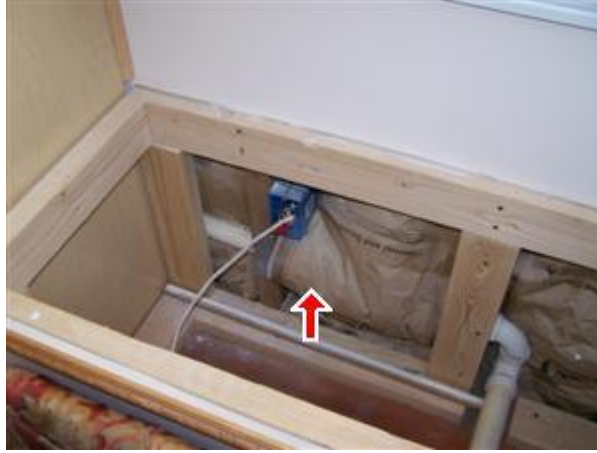
5.4 Picture 2

- ⚡ (2) There is exposed wiring at the electrical junction box at the master bedroom, under the bench seat, connecting power to the wall heater. This is a safety issue that needs to be corrected. A qualified licensed electrician should correct as needed.

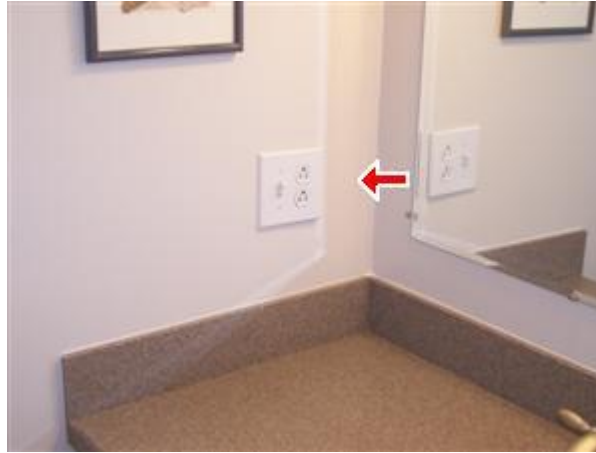
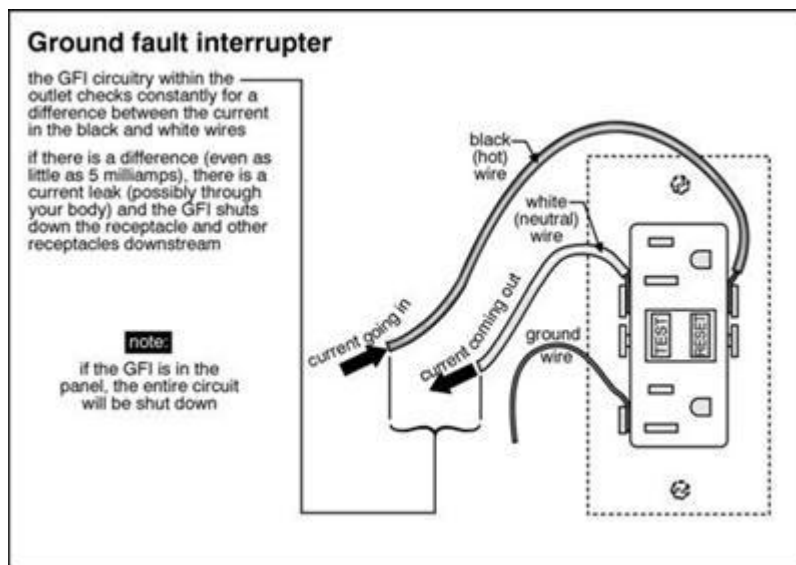
- There is no GFCI outlet found in bath. This is a required safety component in a bathroom, and at least one device must be installed. I recommend a duplex GFCI outlet be installed by a licensed electrician.

There is no GFCI outlet found in bath. This is a required safety component in a bathroom, and at least one device must be installed. I recommend a duplex GFCI outlet be installed by a licensed electrician.

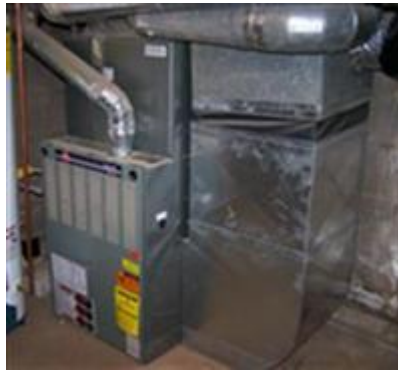
6.0 Picture 1

The gas furnace was fully tested and inspected, and is operating properly at this time. The unit appears to be in good condition. No actions are needed. An annual service check up and cleaning is recommended, to keep the unit in good working condition.

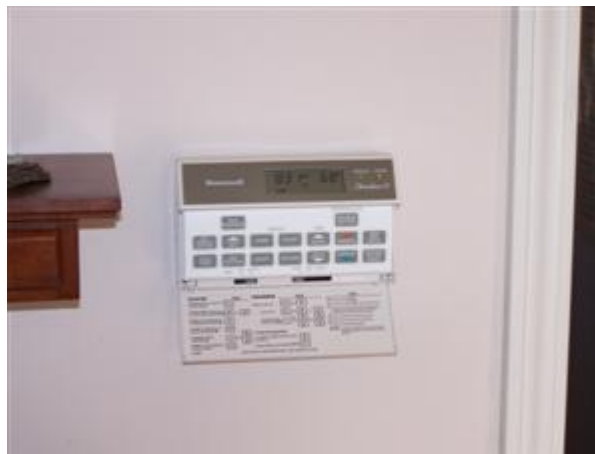
6.1 Picture 1

The thermostat is fully functional, but is loose on wall. This is a minor repair item.

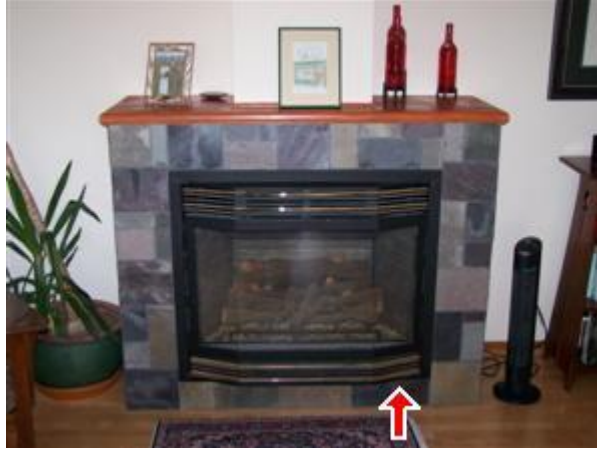
6.5 Picture 1

The gas fireplace was operating at the time of the inspection. There is a gas shut-off valve located where indicated, for the gas appliance shown. This item is noted as a courtesy comment only, for future reference in the event gas shut off is required.

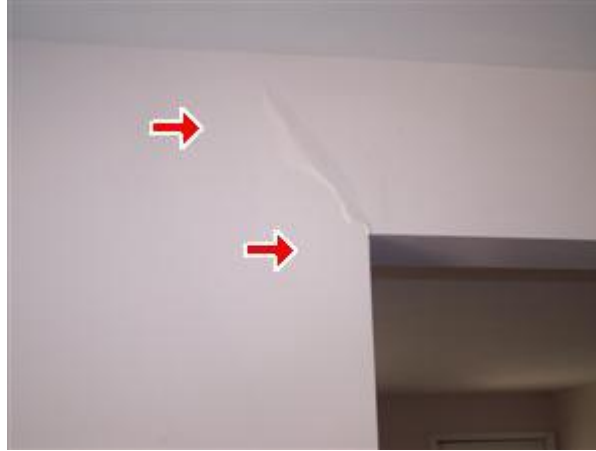
7.1 Picture 1

- The sheetrock on the wall has a hairline, settlement crack at the Dining Room main entryway. This damage is most likely cosmetic, caused by minor settling of the home. The area should be patched and painted, and monitored for continued settlement.

The sheetrock on the wall has a hairline, settlement crack at the Dining Room main entryway. This damage is most likely cosmetic, caused by minor settling of the home. The area should be patched and painted, and monitored for continued settlement.

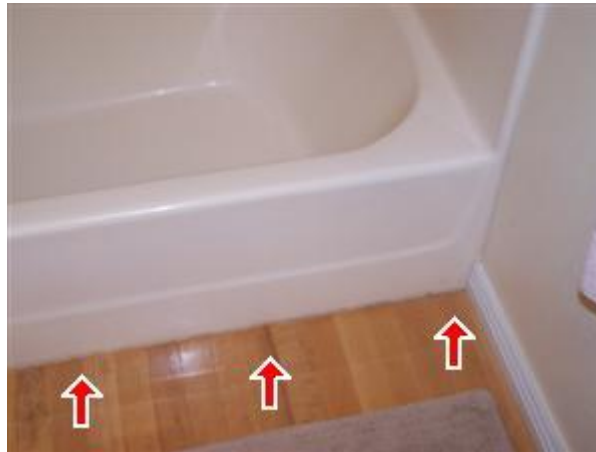
7.2 Picture 1

- I recommend silicone caulk along floor and tub at hall bath. There is some visible deterioration of the existing caulking. Leaking could occur causing damage to sub-flooring and structure. No indication of damage exists today. However the deteriorated caulking should be repaired.

I recommend silicone caulk along floor and tub at hall bath. There is some visible deterioration of the existing caulking. Leaking could occur causing damage to sub-flooring and structure. No indication of damage exists today. However the deteriorated caulking should be repaired.

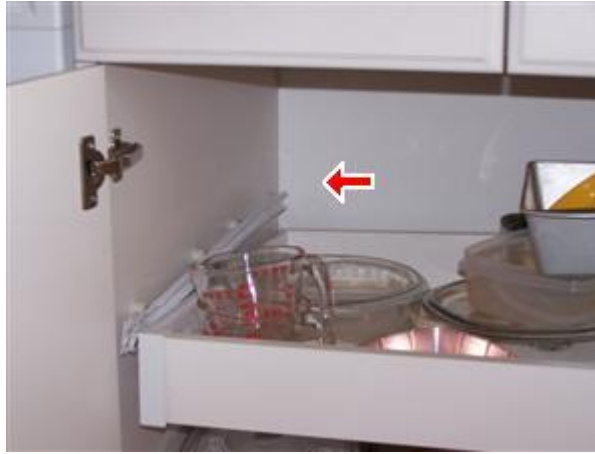
7.5 Picture 1

(1) The drawer track is damaged (right of dishwasher). This is a cosmetic issue for your information. Recommend repair or replace as necessary.

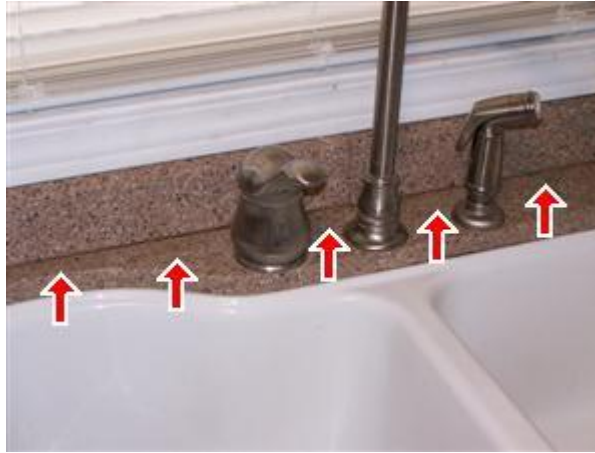
7.5 Picture 2

(2) The area behind the faucet is missing caulking/sealant at the kitchen sink. This area should be caulked to prevent water penetration. Water leaking under home can cause problems such as mold, erosion or deterioration. A qualified person should repair as necessary.

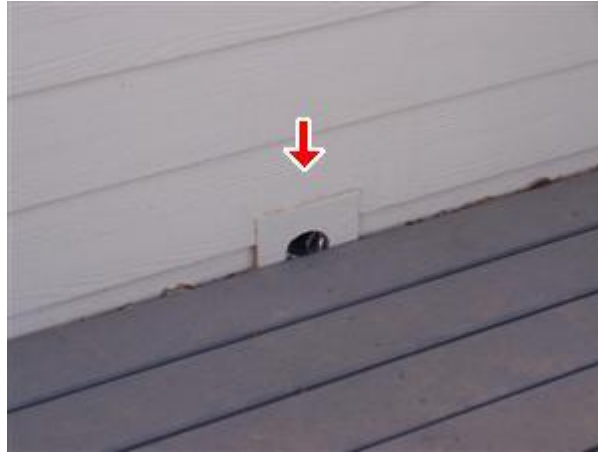
7.7 Picture 1

The dryer vent piping is no longer used at this location. Any un-used vents should be properly terminated and blocked off, to prevent moisture or pest entry into the house. I recommend repair as needed.

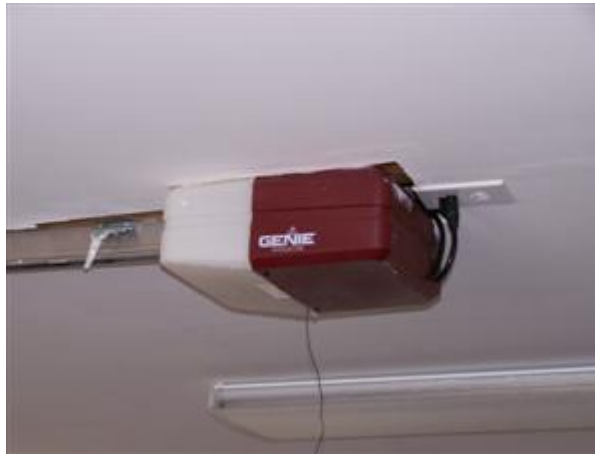
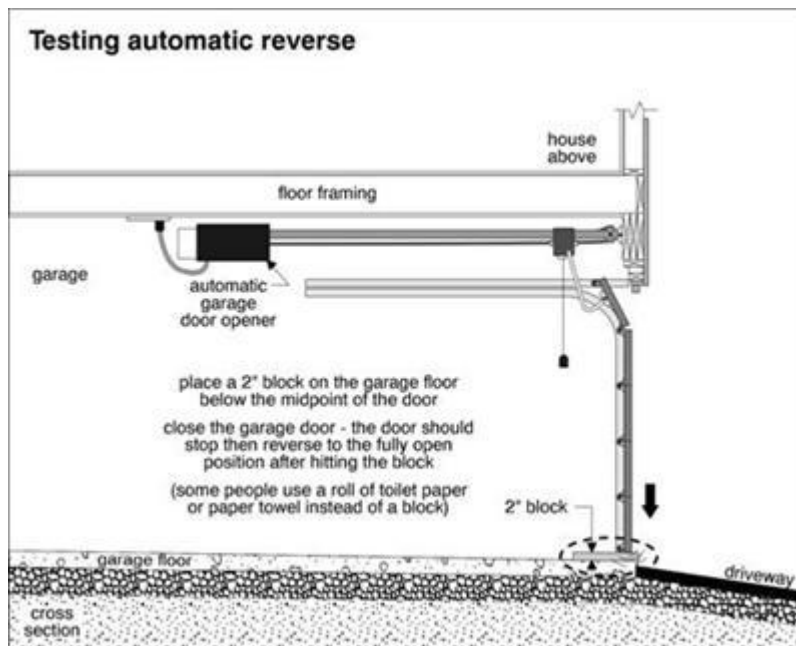
Both Garage Doors will reverse when met with resistance.

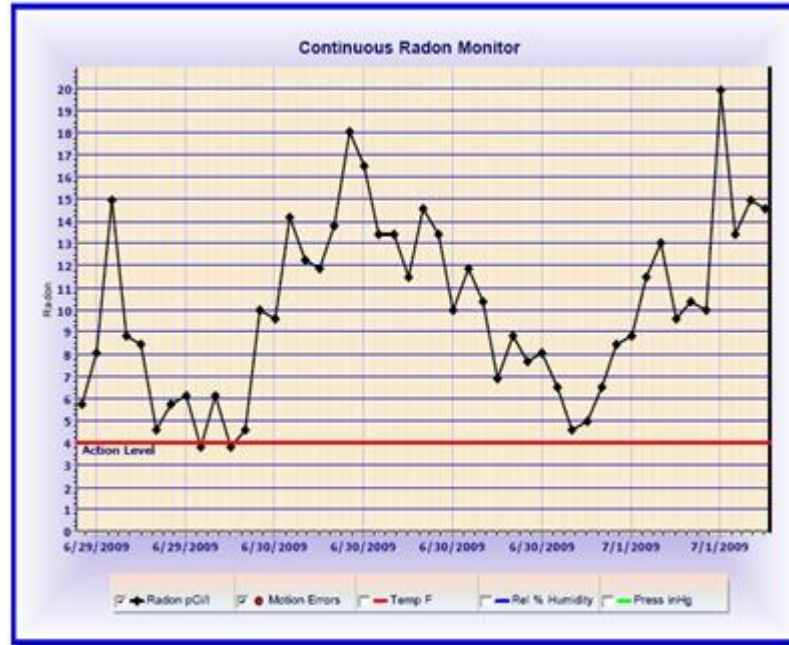
11.5 Picture 1

The final results of the radon measurements are as follows:

Average = 13.1 pCi/L

According to EPA protocols, if the average measured results are equal to or greater than 4 pCi/L, then mitigation is **RECOMMENDED** at this time.
